All the way up!

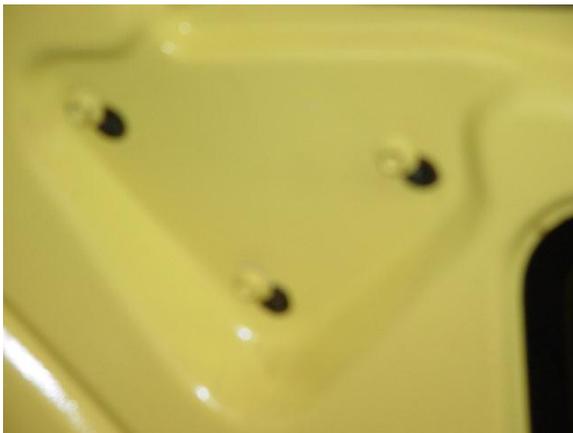
Our Thunderbirds are 50 years old and in some cases some of the parts are well worn and don't work as well as they should. Such is the case when it seems impossible to adjust the door window so that it goes completely up. In my example the window needed to go up at least another $\frac{1}{2}$ inch to be all the way up, despite my best efforts to adjust it by moving the #23230 Idler and adjusting the position of the front post #20314 along with the #21508 rear run. In the example pictured the door cap, door handle, and window regulator handle are removed along with the door panel itself. I then removed the access panel. I also pulled one of the upper limit stops and repositioned it so that the window could not fall down. Place the stop under the portion that stops the upward travel instead of above it. This will keep the glass from falling down while you are making the modification. In the picture below you can see where I removed the three screws holding the mounting portion of the #23234 scissor arms.
